# **Product Performance Report**

CARDIAC RHYTHM MANAGEMENT SECOND EDITION 2023

This Second Edition 2023 of the MicroPort CRM Product Performance Report was prepared in accordance with ISO 5841-2<sup>1</sup>, an international standard for reporting the clinical performance of populations of pulse generators or leads. The third edition of this ISO standard was published in 2014; as part of the revision process, the recommendations from the May 2009 AdvaMed<sup>2</sup> Industry Guidance for Uniform Reporting of Clinical Performance of Cardiac Rhythm Management Pulse Generators and Leads<sup>3</sup> have been incorporated.

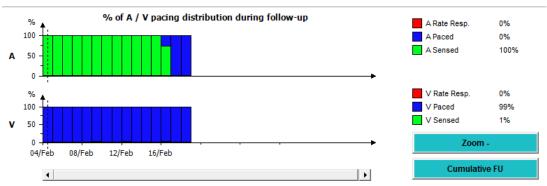
Flat EGMs

Statistics showing 100% pacing

When the failure described in this Field Safety Notice occurs, the device will no longer pace or sense. Due to the absence of sensing, the algorithm will send a pacing command for 100% of the cardiac cycles. The pacing spikes are not delivered due to the hardware failure, but 100% pacing statistics will be shown.
